Interfacing the AMD-761™ System Controller and the Via Technologies, Inc. VT82C686B Southbridge.

Application Note

Interfacing the AMD-761™ System Controller and the Via Technologies, Inc. VT82C686B Southbridge

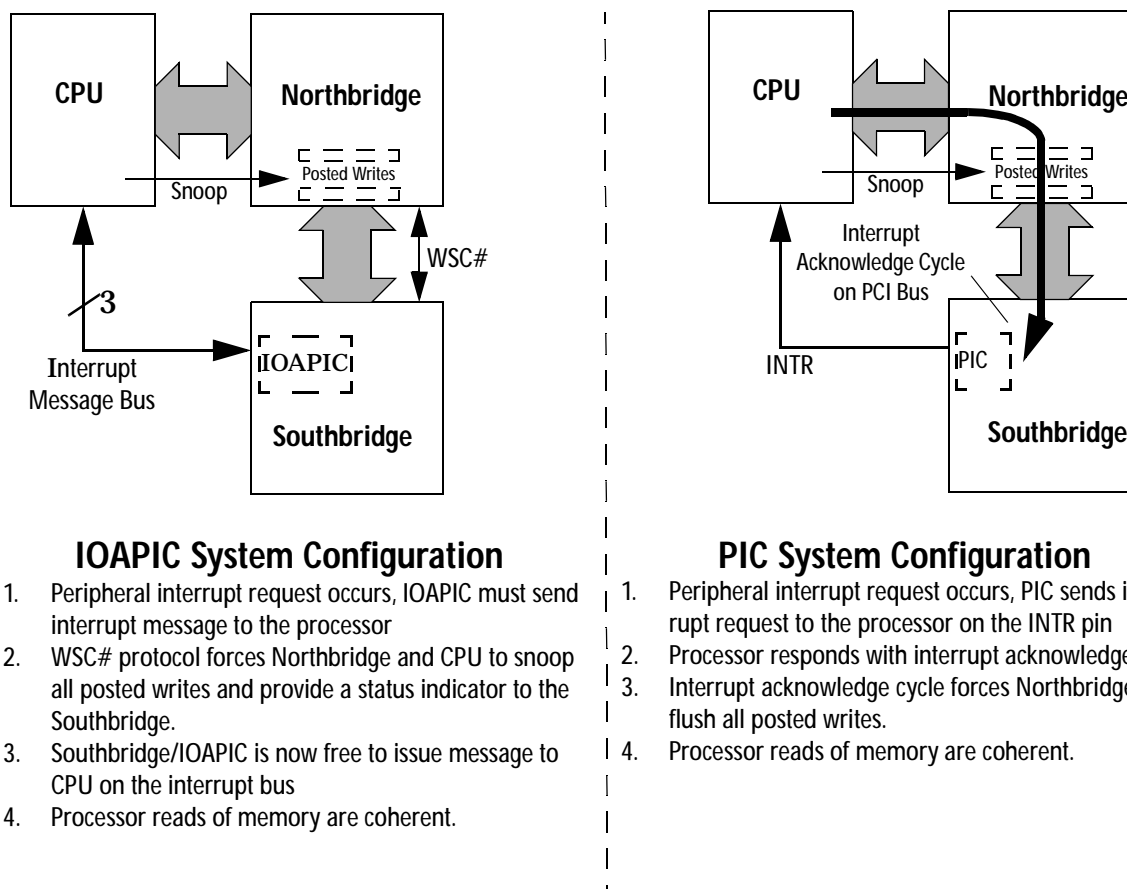
Figure 1.   IOAPIC vs. Traditional PIC System Configuration

Operation with the IOAPIC and the local APIC requires all of the Northbridge's posted write-buffers to be properly flushed to coherent memory before the IOAPIC sends an interrupt message to the processor. This is required to prevent potential data coherency problems that may result when the processor receives an interrupt and reads stale data because the data most recently written by the PCI Bus master still resides in a posted write-buffer in the Northbridge. Non-APIC implementations do not have the potential for this problem because the processor's interrupt acknowledge cycle that traverses the PCI Bus is serializing in nature, thus all posted-write buffers are flushed before the processor reads memory in the interrupt service routine.

1. Peripheral interrupt request occurs, IOAPIC must send interrupt message to the processor
2. WSC# protocol forces Northbridge and CPU to snoop all posted writes and provide a status indicator to the Southbridge.
3. Southbridge/IOAPIC is now free to issue message to CPU on the interrupt bus
4. Processor reads of memory are coherent.

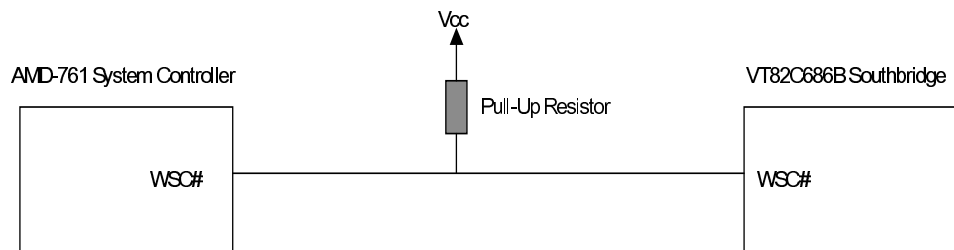
Figure 2.   Typical Configuration

■ The AMD-761 system controller implements WSC# as a bidirectional pin that is first asserted by the Southbridge to request that the posted write-buffers be snooped by the processor, and subsequently asserted by the Northbridge to indicate that the Southbridge's IOAPIC can safely issue an interrupt message to the local APIC. The AMD-761 system controller does not assert the WSC# pin unless it first receives a request on this pin.

■ The VT82C686B implements WSC# as a unidirectional pin that is only driven by the Northbridge and must be asserted low unless the Northbridge has outstanding PCI to DRAM posted writes that have not been snooped by the processor. When the VT82C686B is connected to an AMD-761 system controller, the WSC# pin will never be asserted because the VT82C686B does not first assert WSC# to request posted writes to be snooped, thus the system is not able to send interrupt messages to the processor.

Figure 2 shows an incompatible implementation where the WSC# signal is directly connected between the AMD-761 System Controller and the VT82C686B.

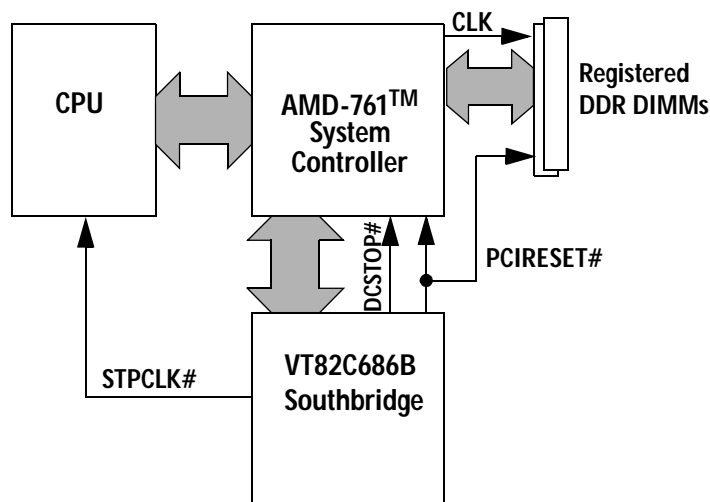
Figure 4.   DDR DIMM Reset Connection in AMD-761™ System Controller System

As shown in Figure 4 on page 6, the reset pin on the DDR DIMMs is connected to the Southbridge PCIRESET# pin in a AMD-761 system controller-based system. When entering the Suspend to RAM state, the AMD-761 system controller continues to drive the DDR clocks for at least four clocks after the PCIRST# pin is asserted to meet the DIMM requirements.

■ The VT82C686B does not follow the DCSTOP# and PCIRESET# sequencing listed above. The VT82C686B does not assert the PCIRESET# pin low until after the power supply has been turned off (PWRGOOD de-asserted). This means that the system clock generator is already powered off by the time the AMD-761 system controller detects the assertion of PCIRESET#. This potentially results in DDR memory failures since the DIMM was not properly shut down.

A solution for this incompatibility does not exist at this time. AMD does not recommend the use of the AMD-761 system controller with the VT82C686B Southbridge in registered DIMM applications.

Unbuffered DIMM applications using the AMD-761 system controller with the VT82C686B Southbridge function properly.
